EVALUATION REPORT 353

CO-OP IMPLEMENTS 742 SELF-PROPELLED WINDROWER

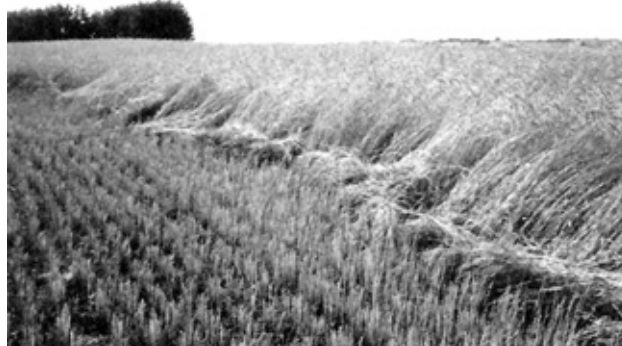
Dividers: In average straight standing crops, divider performance was satisfactory. However, the wide divider and knife drive box normally flattened a strip of crop, causing a slight crop loss (FIGURE 1). Cutting in the opposite direction on the next pass recovered most of the flattened crop. The centre divider plugged in wet and tangled rapeseed and had to be cleared with the reel. It is recommended that the manufacturer consider modifications to improve the performance of the dividers.

FIGURE 1. Crop Flattened by the Divider.

1. Modifications to improve the performance of the dividers.
2. Modifications to the reel lift system to make it more convenient to operate.
3. Relocating the instrument console for more convenient viewing or providing audible alarms for all instruments.

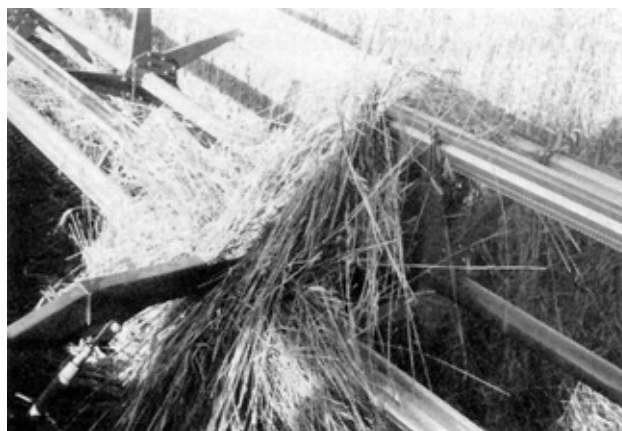
Reel: Reel speed was variable from 0 to 84 rpm. Reel tip speed ranged from 0 to 14 mph (0 to 23 km/h). The reel was usually adjusted for a reel speed index* of 1.1 to 1.2 to minimize shatter losses, in heavy and tangled crops, material occasionally caught on the two centre reel arms, and stopped the reel (FIGURE 2).

FIGURE 2. Material Caught on the Reel Arm.

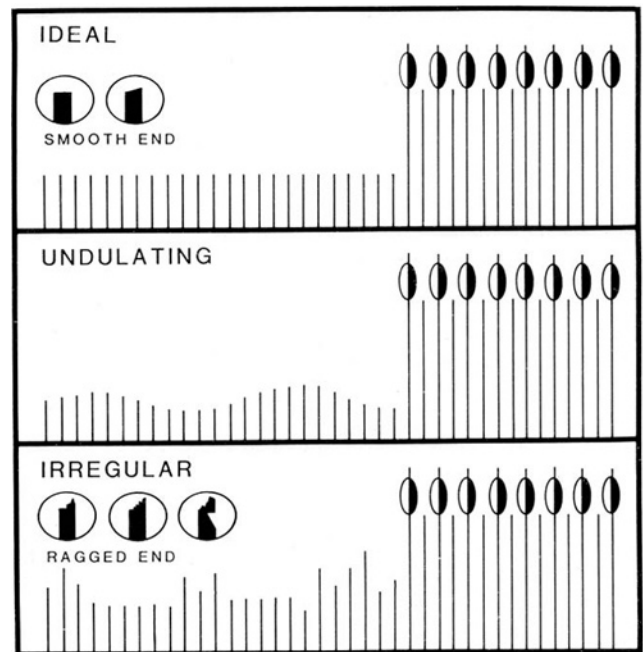
Cutterbar: Cutting ability was very good in cereal crops and straight standing oilseed crops. Stubble was usually ideal (FIGURE 3). In tangled green rapeseed crops, material collected on dull sections of the knife. In hard-to-cut crops, it was important to replace worn knife sections and guards.

FIGURE 3. Types of Stubble.

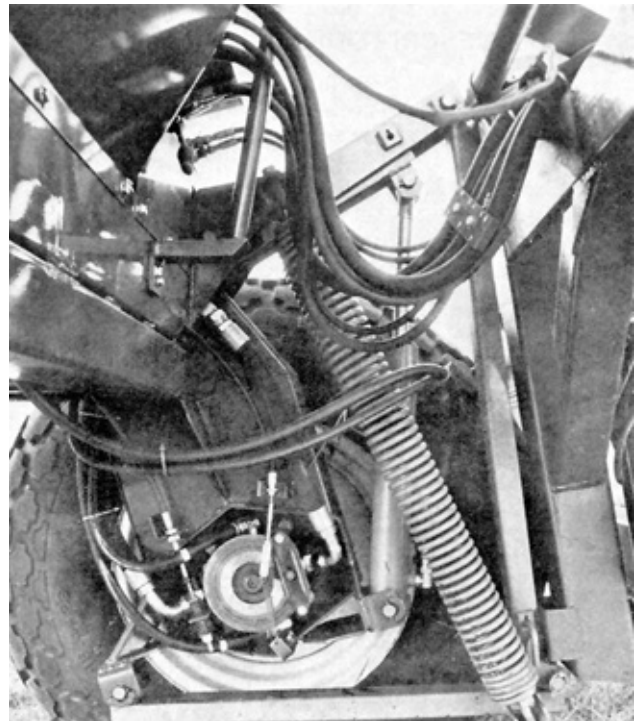
Header Flotation: Header flotation was very good. Flotation was provided by four tension springs on the traction unit (FIGURE 4) and two tension springs on each wing wheel (FIGURE 5). Header flotation minimized cutterbar damage in stony fields. The hinged wings enabled the header to follow most ground contours. Undulating stubble occurred only in very rough fields.

FIGURE 4. Header Flotation System Main Springs.

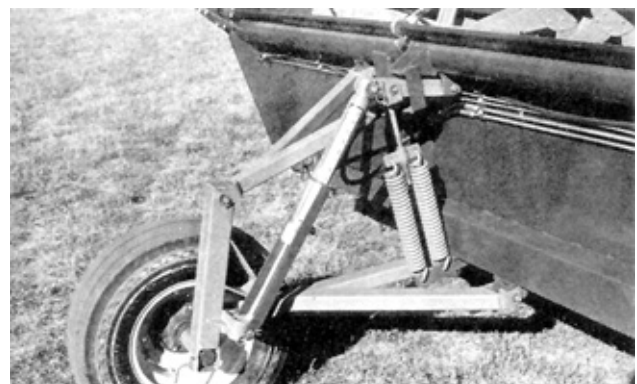
FIGURE 5. Wing Flotation System.

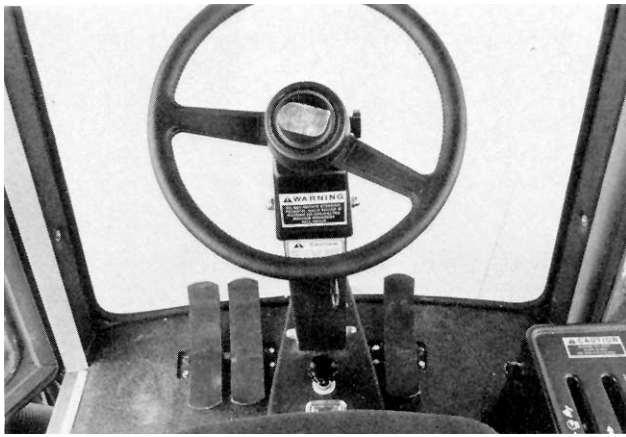
Controls: Most of the controls for the CI 742 (FIGURES 12 and 13) were conveniently located, properly identified and easy to operate. The range shifter was difficult to engage, as it had to be forced into place. The travel speed control lever was convenient to operate in both field and transport positions.

FIGURE 12. Steering Column and Foot Controls.

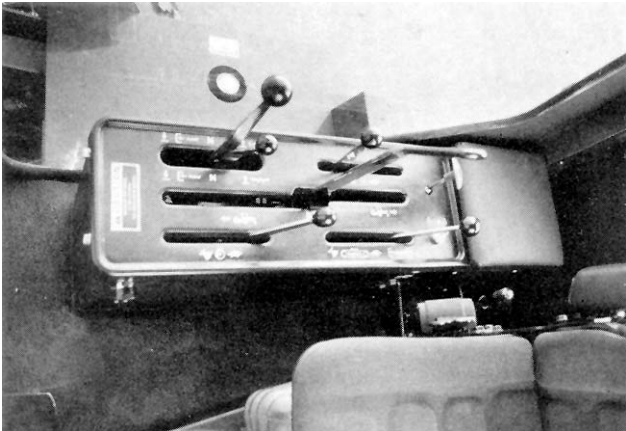
FIGURE 13. Hand Controls.

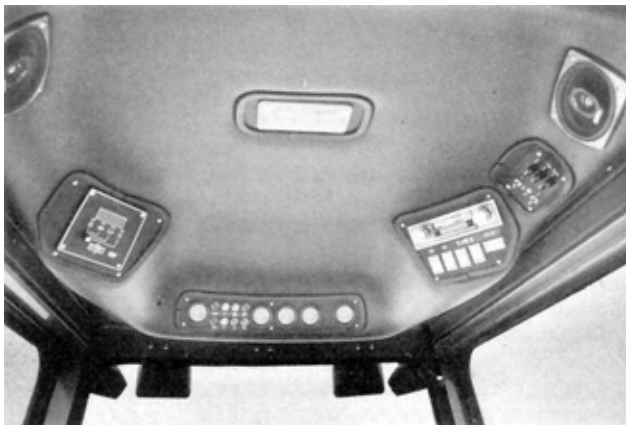
Instruments: The instrument console was located above the front windshield (FIGURE 14). It included gauges for fuel level, engine oil pressure, coolant temperature, battery voltage, and hydraulic oil temperature. Warning lights indicated neutral starting switch status; park brake engagement; engine, header and hydrostatic drive filter conditions; and the hydrostatic oil pressure. An audible alarm signalled an unsafe starting or operating condition. The instruments were located out of the operator's line of sight and were not easily noticeable. In full transport, the gauges were behind the operator. It is recommended that the manufacturer consider relocating the instrument console for more convenient viewing or providing audible alarms for all instruments.

The digital monitor did not indicate true engine, draper, reel, or travel speeds. Recalibrating engine speed only produced a correct reading at full speed. It is recommended that the manufacturer consider modifications to improve the digital monitor accuracy.

FIGURE 14. Instrument Panel.

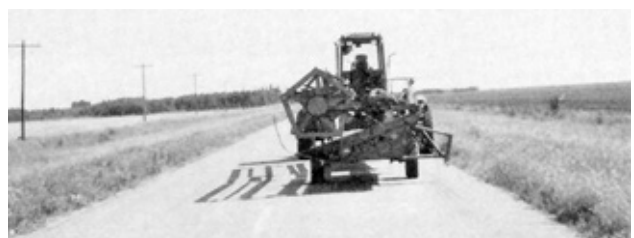
Transporting: The CI 742 travelled very well on open roads in semi-transport at speeds up to 7 mph (11 km/h), and in full transport (FIGURE 15) at speeds up to 10.5 mph (17 km/h). In semi-transport, the wings were high enough to clear most obstructions, but the unit was too wide for meeting traffic. In full transport, the header trailed well and the unit negotiated corners easily and safely.

FIGURE 15. Full Transport Position.

Machine adjustments were safely and easily made. Controls were located near the operator for safe operation. In full transport, the instruments were not visible and no rearview mirror was provided. It is recommended that the manufacturer consider providing a rearview mirror for safer operation in full transport.
